SEALANT, WATERPROOFING & RESTORATION INSTITUTE • SUMMER 2023 • 45.3

# HEARST CASTLE'S NEPTUNE POOL: RESTORED TO GLORY

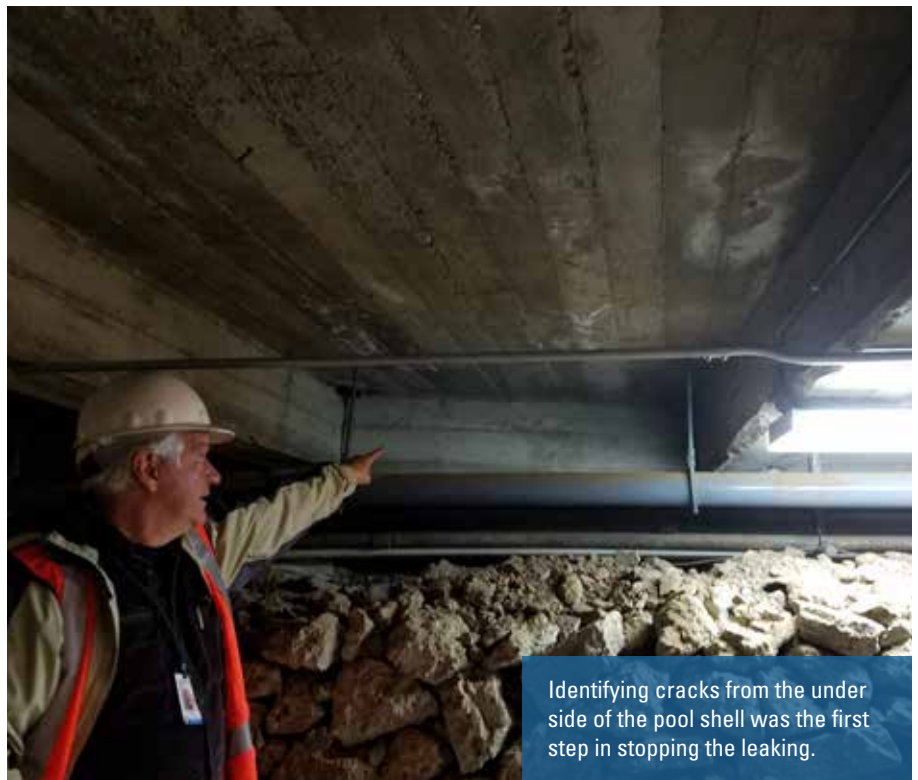
Identifying cracks from the underside of the pool shell was the first step in stopping the leaking.

The plan for stopping the water leak began with the identification of cracks in the pool shell. Repairing the cracks, totaling nearly 5,000 linear feet, involved injecting urethane foam grout into the cracks, mainly from the under side of the pool shell. The workspace under the pool ranged from two feet to four feet, making access to the furthest points of the pool difficult for the installers to get to. Because the pool shell was 14 inches thick, getting the equipment to drill the injection ports into the right areas, with enough room to drill at the correct locations and angles, created unique challenges, at times requiring minor excavation of soil to gain proper access to the work areas. Due to years of water leakage, stalactites ranging from ¼ inch to 20 inches had grown from the bottom of the shell. This helped the installers identify the cracks that needed to be injected from the bottom side. Once the injection was completed, multiple cores were taken from the shell over the cracks to make sure the foam grout had migrated throughout the crack. Once the inspectors for the state of California had approved the injection efforts, waterproofing inside the pool shell was ready to begin.

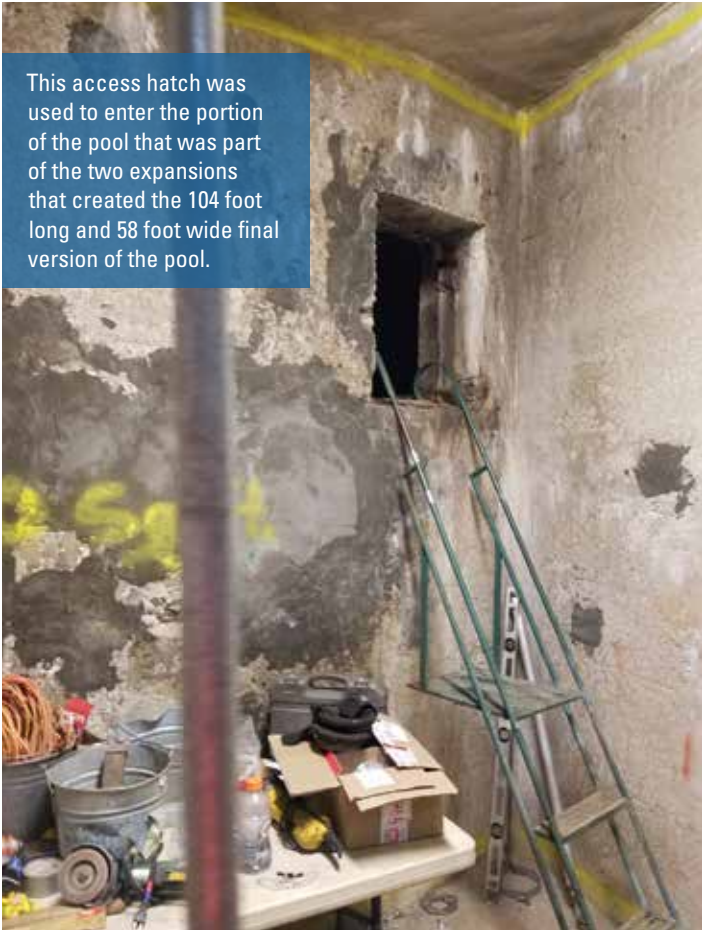
This access hatch was used to enter the portion of the pool that was part of the two expansions that created the 104 foot long and 58 foot wide final version of the pool.

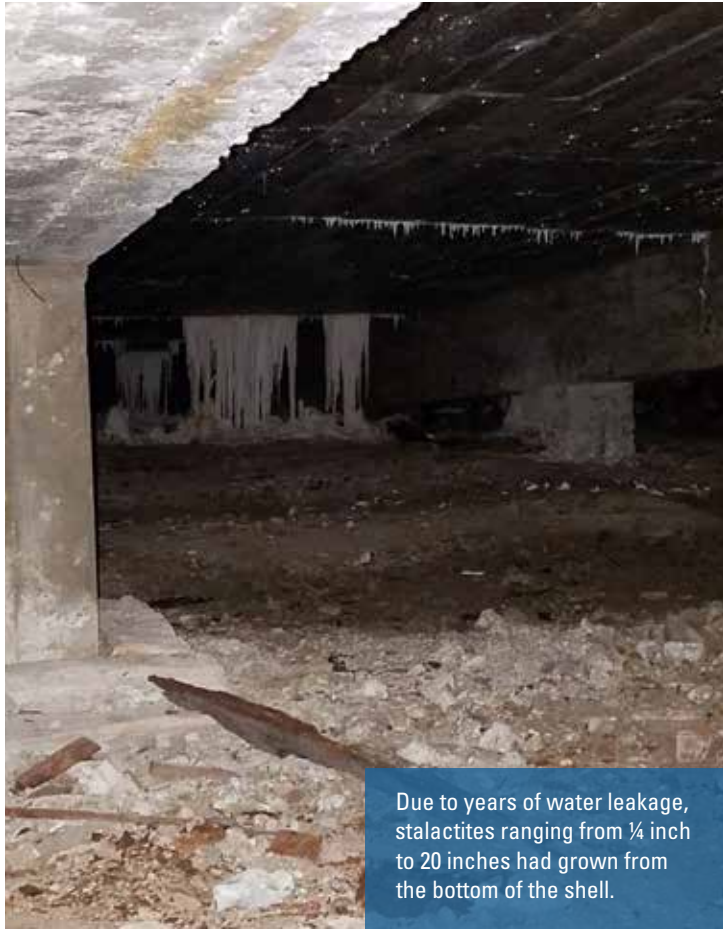
Due to years of water leakage, stalactites ranging from ¼ inch to 20 inches had grown from the bottom of the shell.

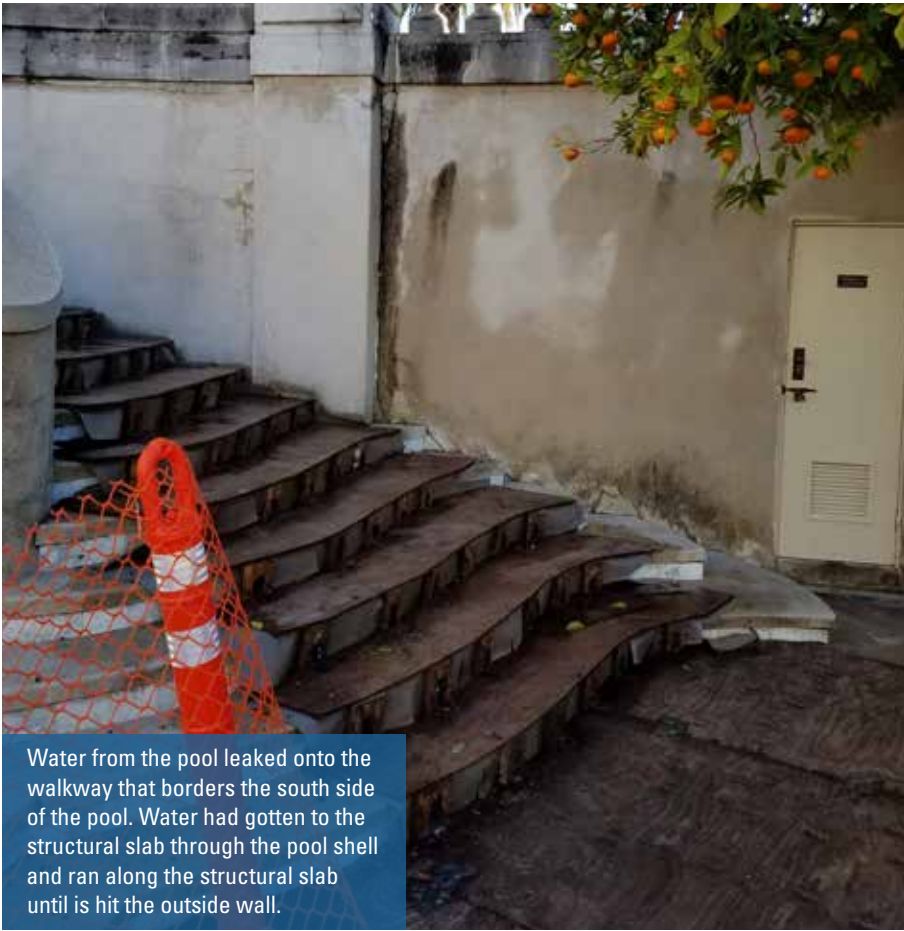
Water from the pool leaked onto the walkway that borders the south side of the pool. Water had gotten to the structural slab through the pool shell and ran along the structural slab until it hit the outside wall.

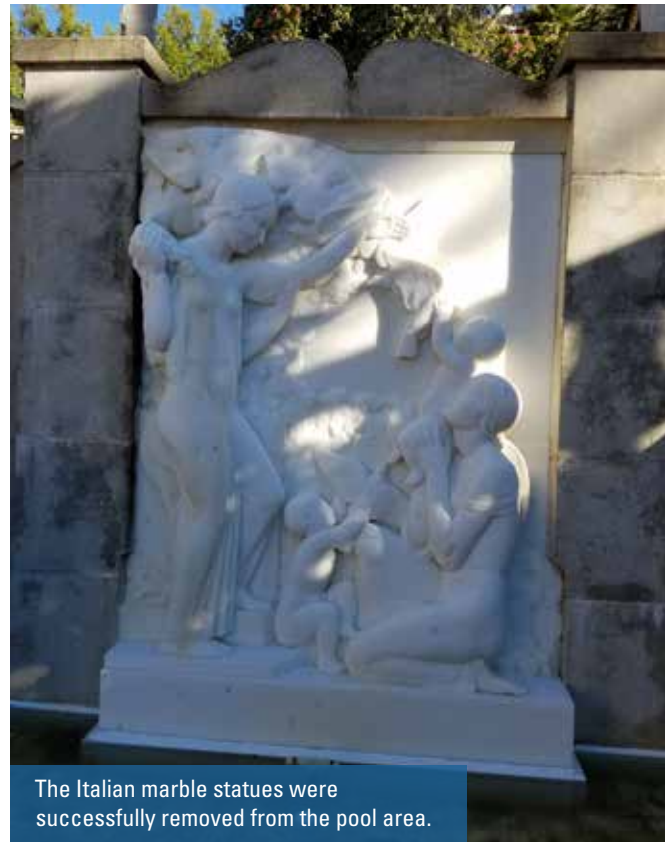
The Italian marble statues were successfully removed from the pool area.

from the same Vermont quarry that furnished the original tiles. The new tiles then had to be sorted by color gradation to make sure they could blend the shades of white throughout the pool and adjacent basins, so as not to be noticed by the thousands of annual visitors. The Italian marble statues were successfully removed and stored for the duration of construction efforts.

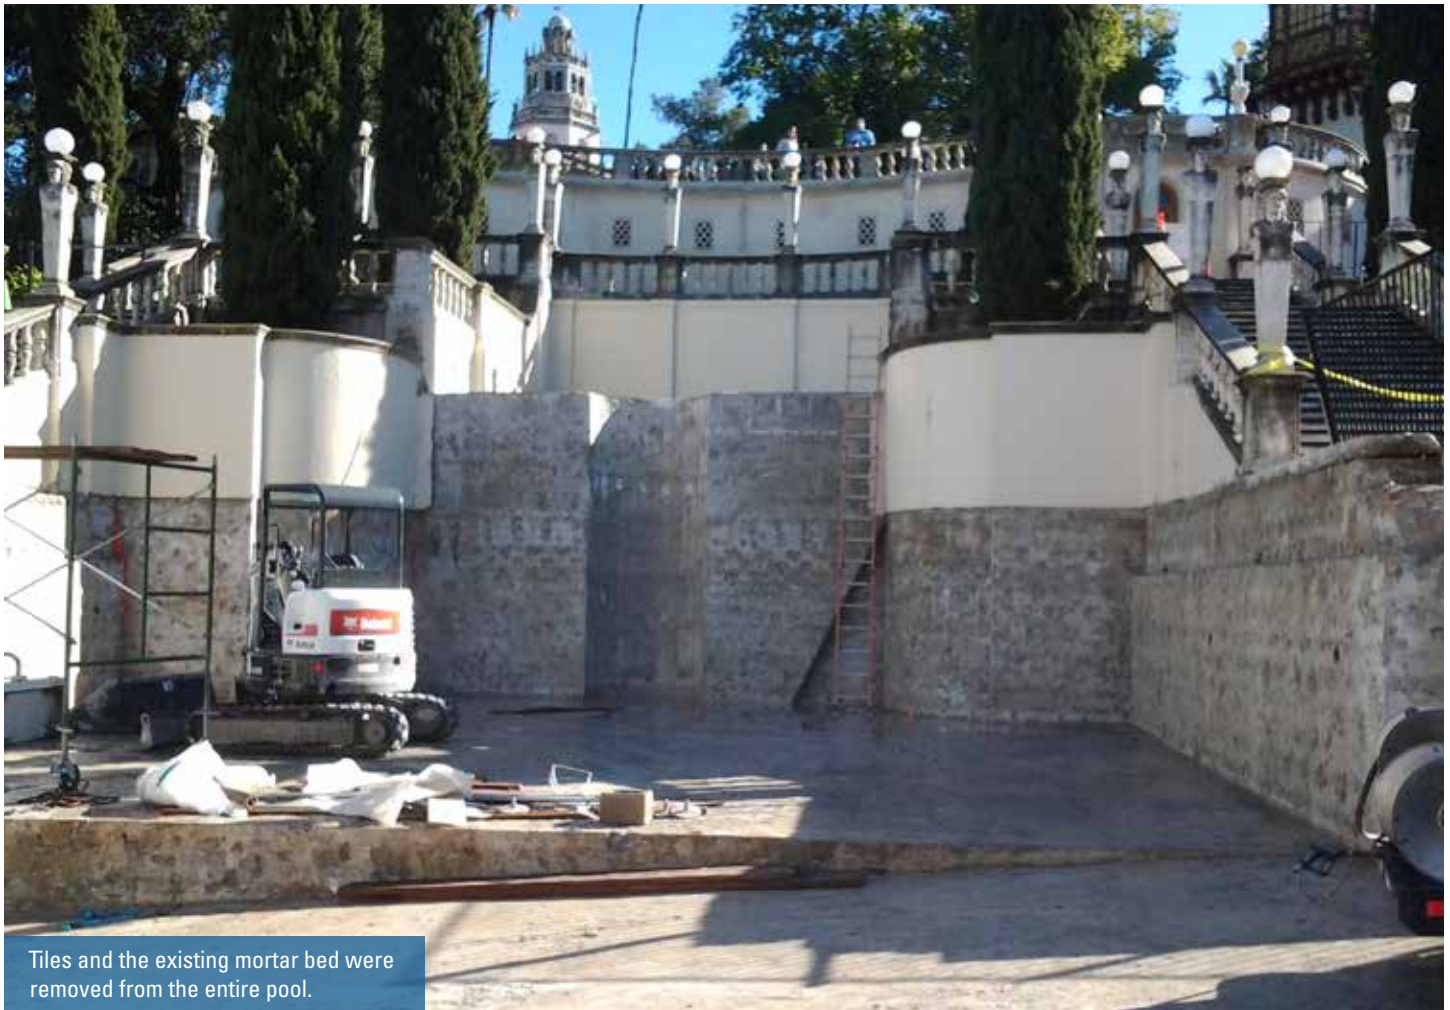
Tiles and the existing mortar bed were removed from the entire pool.

The removal of the existing tiles and mortar bed was difficult and made salvaging the original marble tiles impossible. As a result, the design team was forced to order new marble tiles

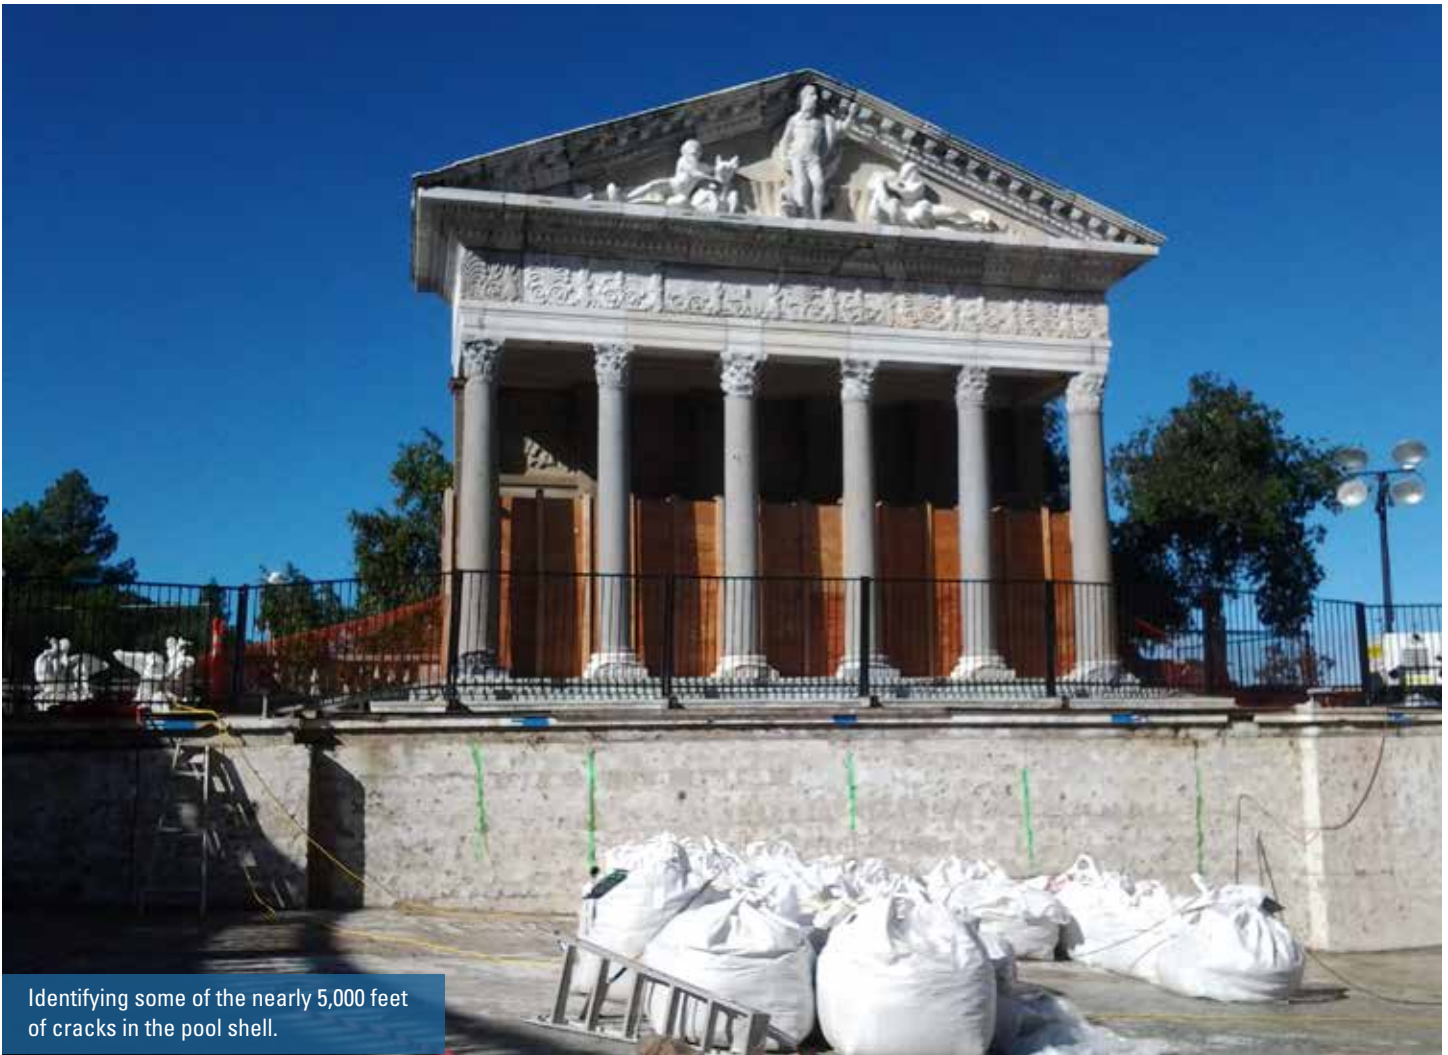
Identifying some of the nearly 5,000 feet of cracks in the pool shell.

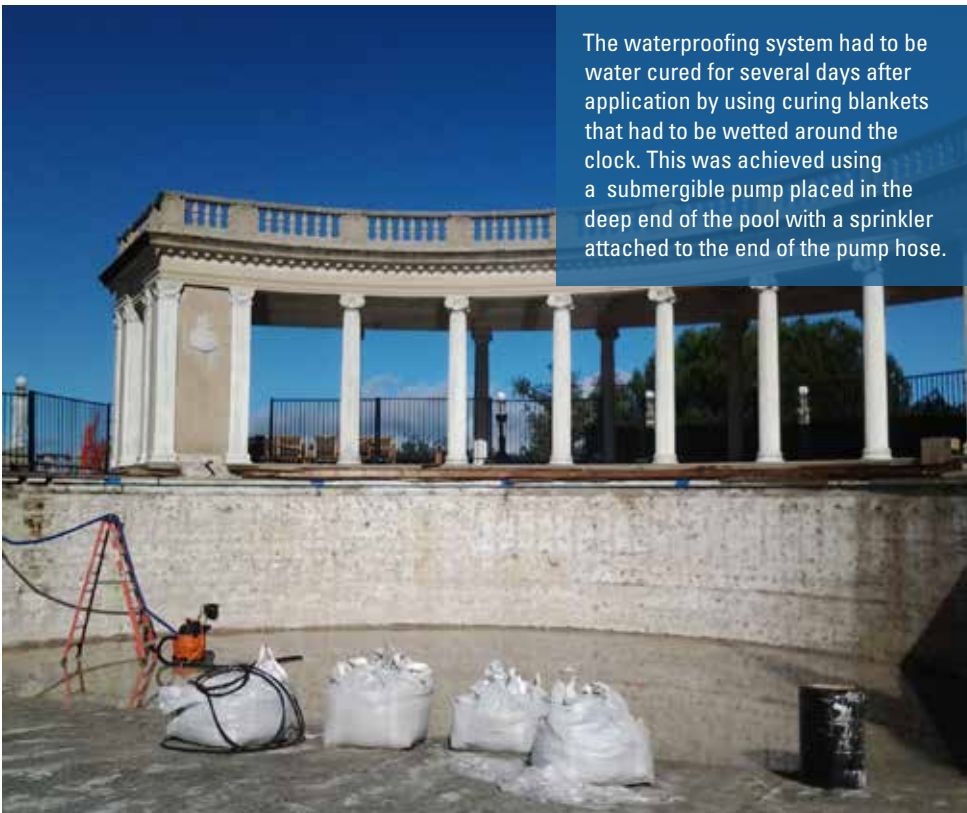
The waterproofing system had to be water cured for several days after application by using curing blankets that had to be wetted around the clock. This was achieved using a submersible pump placed in the deep end of the pool with a sprinkler attached to the end of the pump hose.

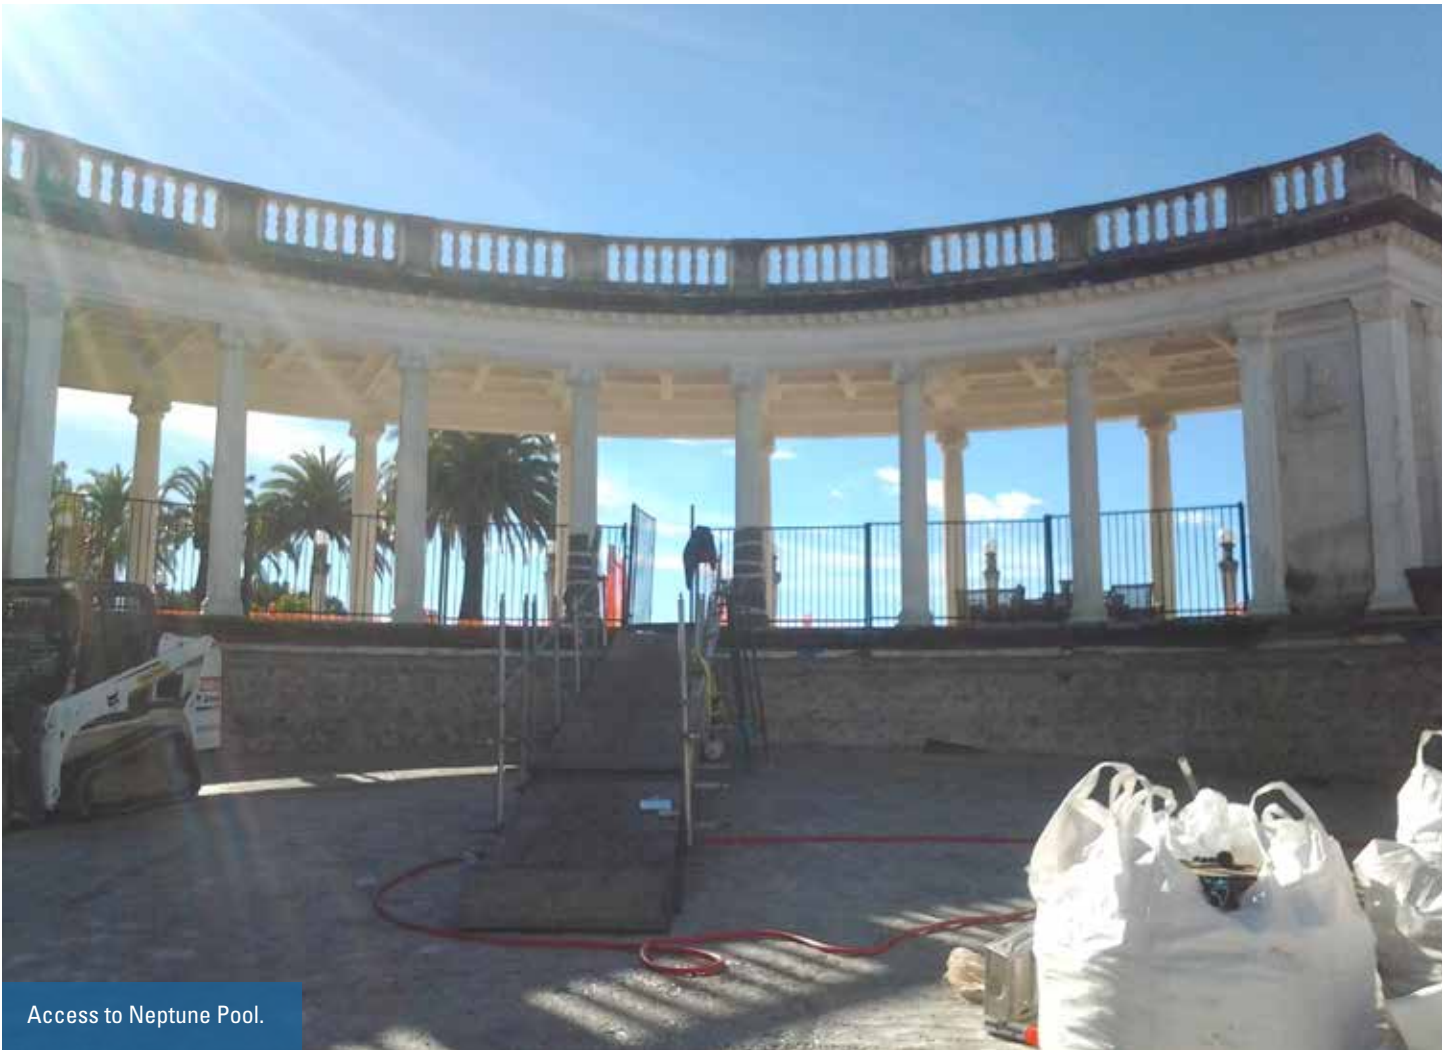
Access to Neptune Pool.

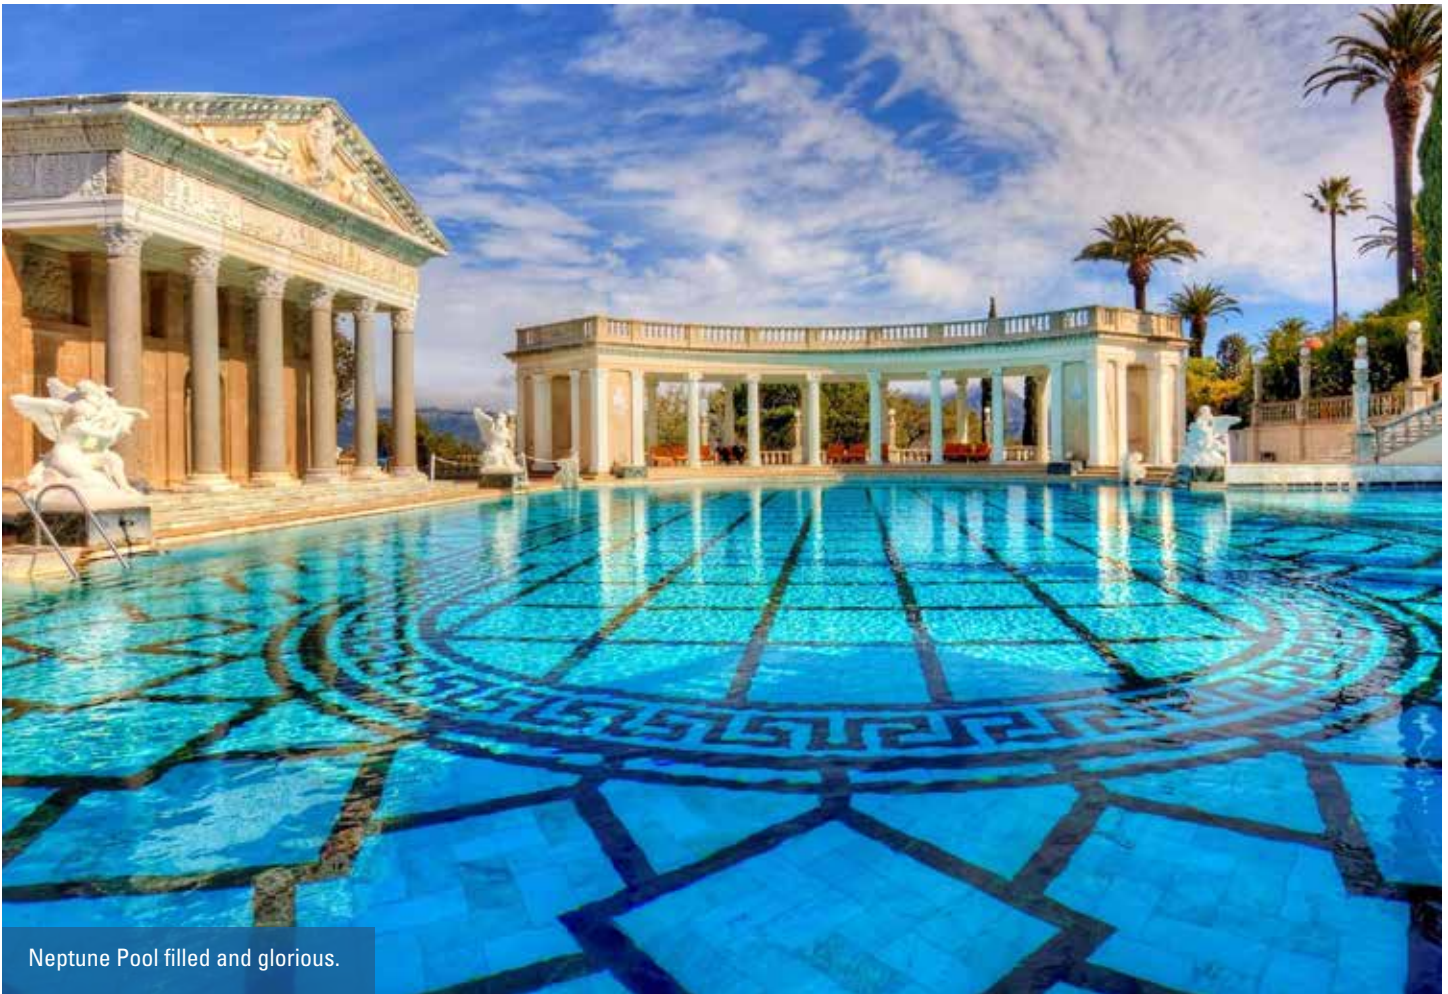
Neptune Pool filled and glorious.

coated and a three-inch mortar bed was installed prior to the reinstallation of the tile. Due to the complexity of the tile layout, this process took several months. Once the tile had been placed and the pool refilled, it marked the first time in the 90-year history of the Neptune Pool that it was leak free.
